Smoke and Dye Testing Summary

High Level Sewershed

Run Summary

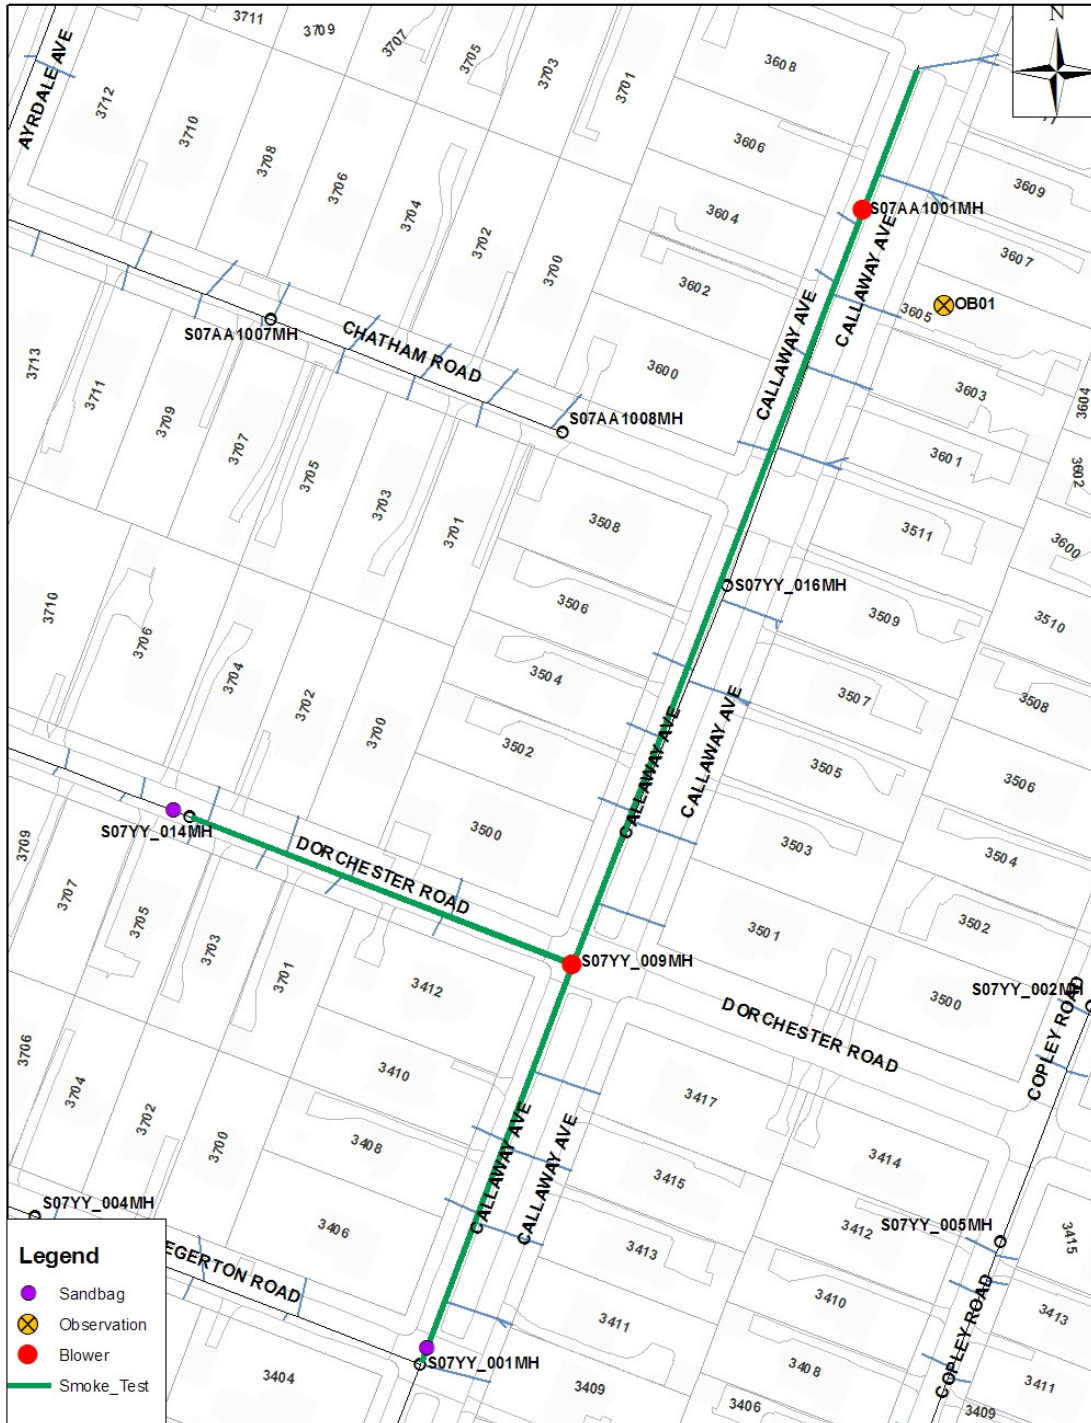
Obs_ID S1028-002-OB01

Source Cleanout

Location Yard - front

Comments Smoke from cleanout in front yard. 3605 Callaway Ave.
